# Mont Orgueil restoration

The £1 million refurbishment of Mont Orgueil Castle is now in full swing and on target for completion in March 2006. The project will restore parts of the ancient building that have fallen into disrepair and is being run in close consultation with the Société Jersiaise Archaeology Section and the Environment and Public Services Committee. Skilled local craftsmen, as well as experts from UK and France, are carrying out the work using traditional materials such as lead, wrought iron, lime mortar, granite and oak. This illustration shows the range of repairs being undertaken.

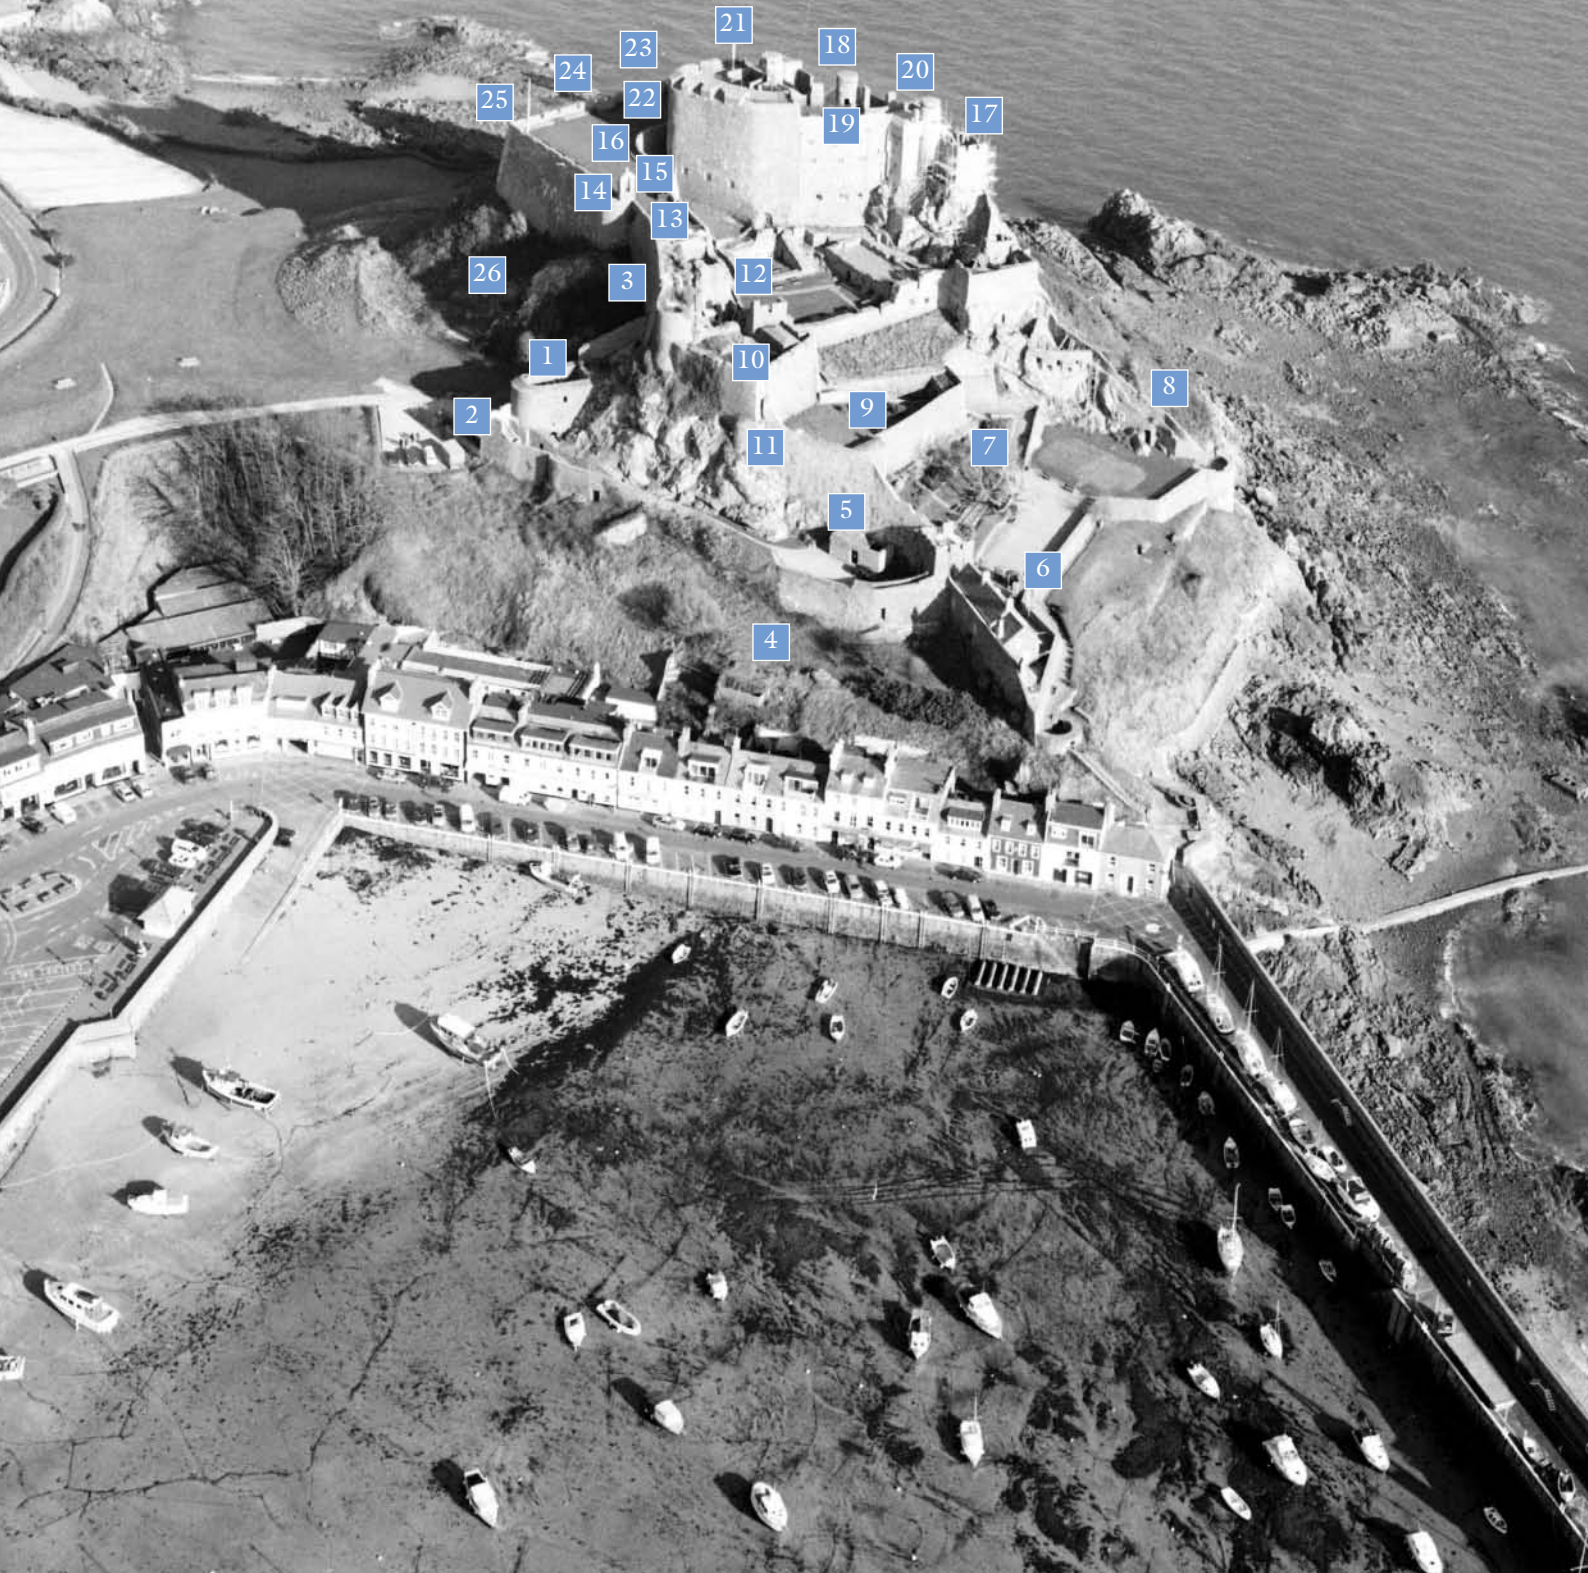
Aerial photograph of Mont Orgueil Castle and Gorey Harbour. (Robin Briault)

1. Repair wall heads of Harliston Tower with lime mortar
2. New gates and repairs to pintles for the First Gate
3. Remove ivy and repair masonry of curtain wall

4. Create new public garden and access route from Gorey Pier
5. Create new ticket office within the old stable store
6. Old kiosk and railings in Lower Ward removed

7. New planting and steps aligned with Charles II coat-of-arms
8. Repairs to the south-east wall walk
9. Archaeological investigation and new public access to De Carteret's Rampart garden

10. Archaeological investigation and new public access to Sir John Peyton's Bulwark
11. Archaeological investigation and masonry consolidation of Southern flanking tower

12. Removal of modern features in the Middle Ward
13. Archaeological investigation and lowering of the Lower Grand Battery
14. Repairs to stonework of Bell Tower

15. Archaeological investigation within the Bell Tower associated with new services route
16. Removal of 20th century features from the Grand Battery
17. Lime repointing of Prynne's and Square Keep Towers

18. Repairs to World War II concrete cappings
19. New lead for Residential Apartment roofs
20. New pantile roof for Mediaeval Great Hall
21. Environmental monitoring of the Keep and re-roofing of open areas to control rainwater ingress

22. North-east Tower repaired and opened to the public, linking with the newly opened North-east Passage
23. New WC in old latrine
24. North-east outworks recorded and made safe

25. Wall head repairs, new railings and dolphin-watching platform in Caesar's Fort
26. Liaison with Environmental Department to ensure flora and fauna are preserved and habitats enhanced all round the castle
