Mont Orgueil restoration

The £1 million refurbishment of Mont Orgueil Castle is now in full swing and on target for completion in March 2006. The project will restore parts of the ancient building that have fallen into disrepair and is being run in close consultation with the Société Jersiaise Archaeology Section and the Environment and Public Services Committee. Skilled local craftsmen, as well as experts from UK and France, are carrying out the work using traditional materials such as lead, wrought iron, lime mortar, granite and oak. This illustration shows the range of repairs being undertaken.

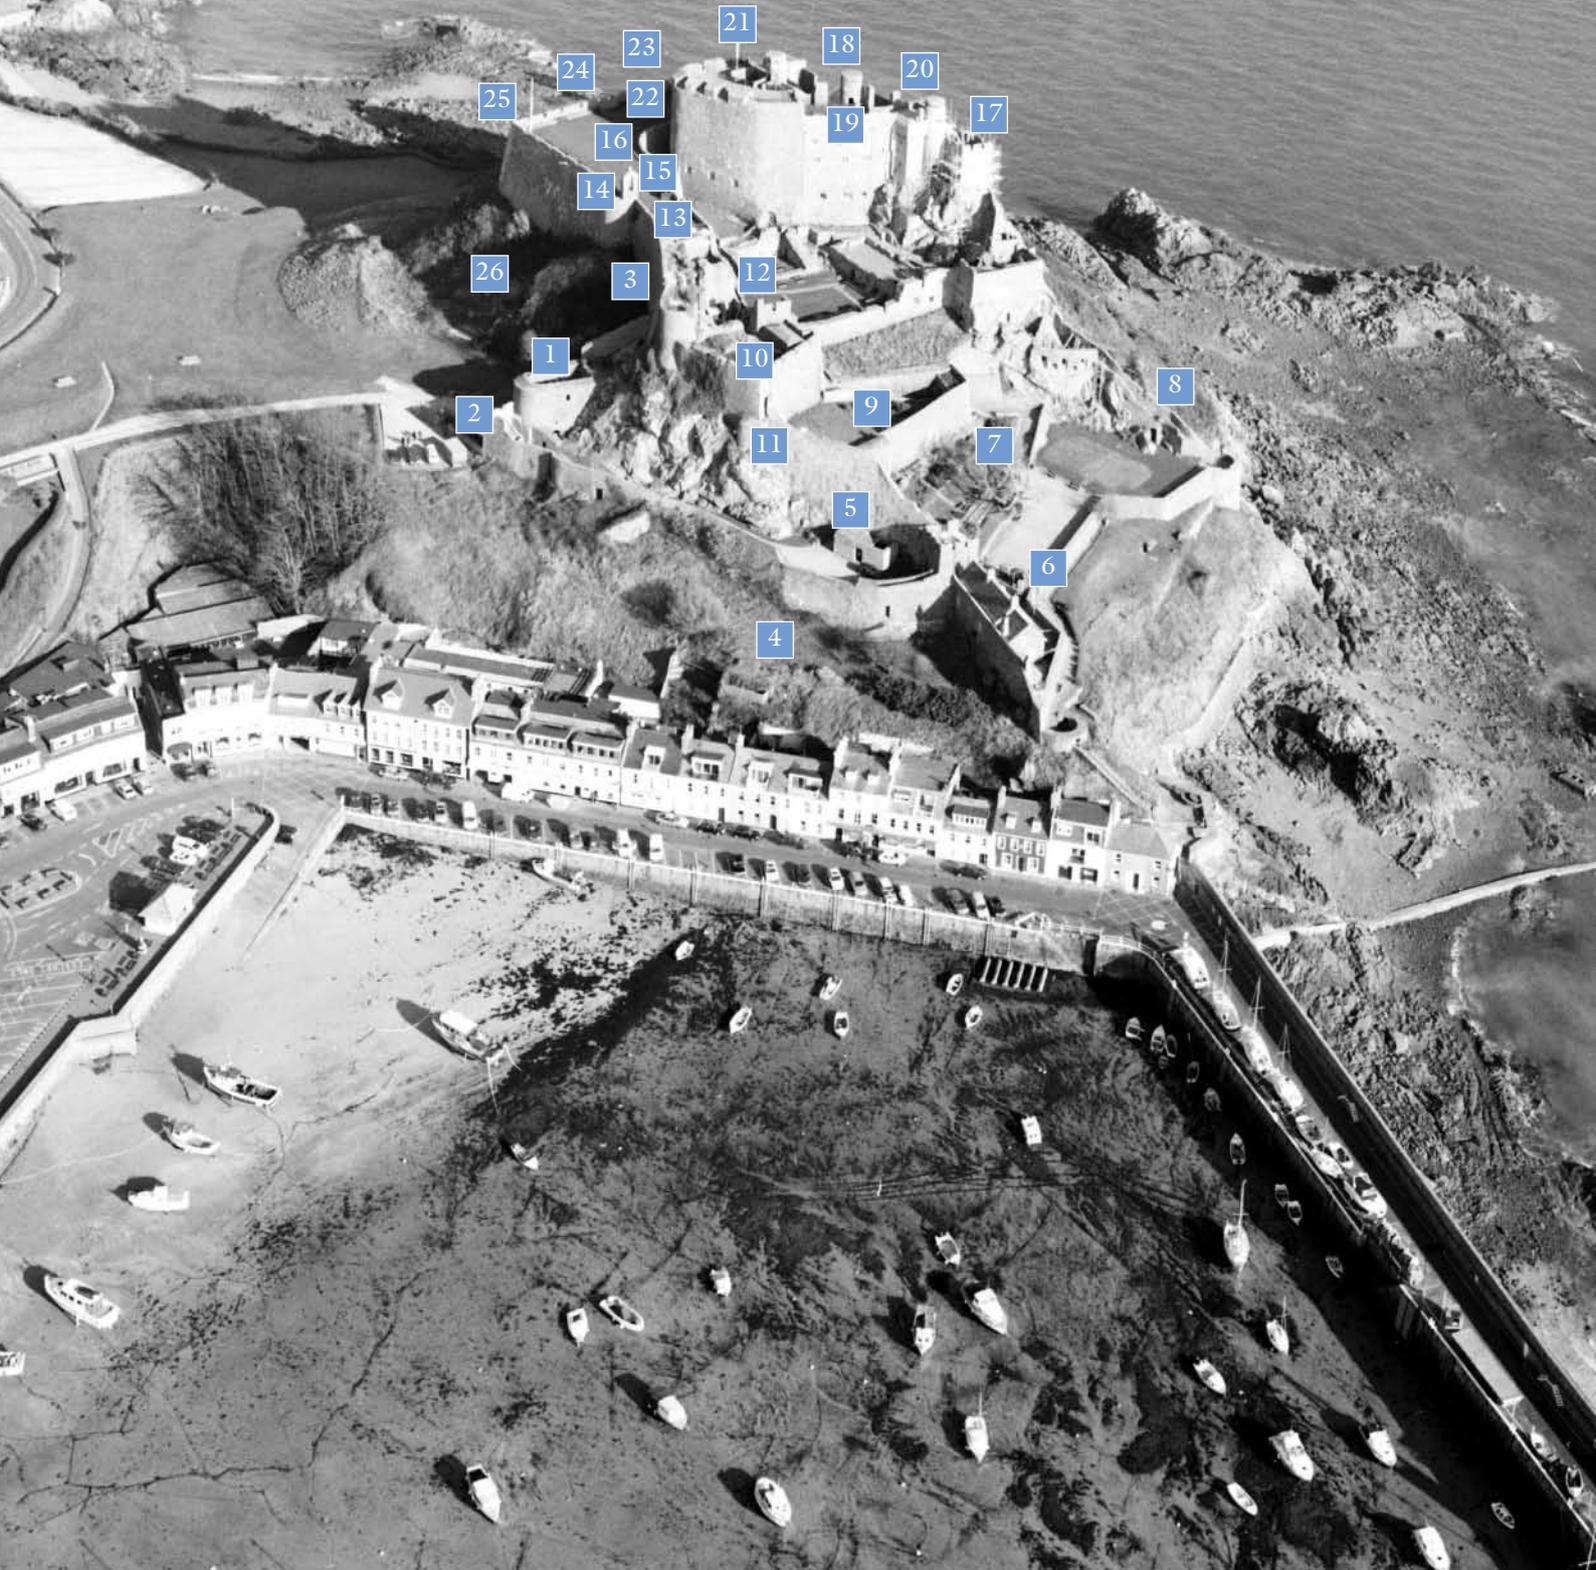
Aerial photograph of Mont Orgueil Castle and Gorey Harbour. (Robin Briault)

1. Repair wall heads of Harliston Tower with lime mortar
2. New gates and repairs to pintles for the First Gate
3. Remove ivy and repair masonry of curtain wall

4. Create new public garden and access route from Gorey Pier
5. Create new ticket office within the old stable store
6. Old kiosk and railings in Lower Ward removed

7. New planting and steps aligned with Charles II coat-of-arms
8. Repairs to the south-east wall walk
9. Archaeological investigation and new public access to De Carteret's Rampart garden

10. Archaeological investigation and new public access to Sir John Peyton's Bulwark
11. Archaeological investigation and masonry consolidation of Southern flanking tower

12. Removal of modern features in the Middle Ward
13. Archaeological investigation and lowering of the Lower Grand Battery
14. Repairs to stonework of Bell Tower

15. Archaeological investigation within the Bell Tower associated with new services route
16. Removal of 20th century features from the Grand Battery
17. Lime repointing of Prynne's and Square Keep Towers

18. Repairs to World War II concrete cappings
19. New lead for Residential Apartment roofs
20. New pantile roof for Mediaeval Great Hall
21. Environmental monitoring of the Keep and re-roofing of open areas to control rainwater ingress

22. North-east Tower repaired and opened to the public, linking with the newly opened North-east Passage
23. New WC in old latrine
24. North-east outworks recorded and made safe

25. Wall head repairs, new railings and dolphin-watching platform in Caesar's Fort
26. Liaison with Environmental Department to ensure flora and fauna are preserved and habitats enhanced all round the castle
